**Informe 52ª Campaña – SEMANA 37**  
**Control Ambiental de fibras de amianto durante la  
recuperación-sellado de la Vaguada de Larres**

**Referencia: 02-905-255066-37**

Fecha : 20/09/2019

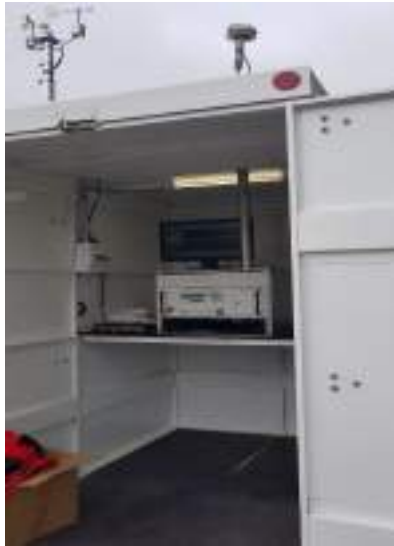
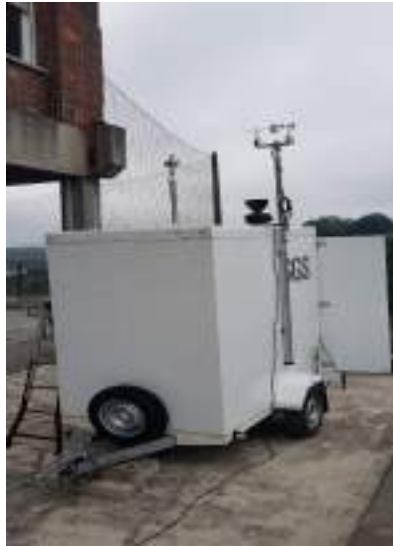
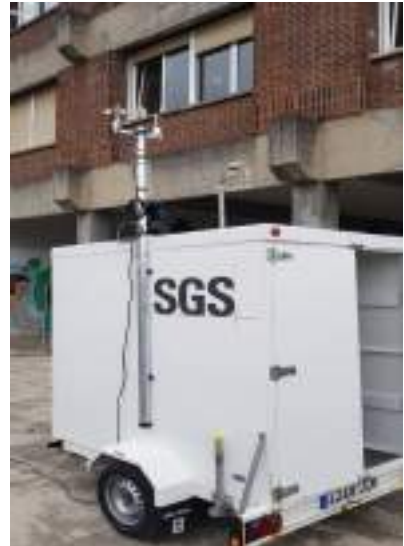
Figura 9. Ubicación e implantación de la unidad de calidad del aire en Ikastola Oleta

La monitorización continua y portátil del polvo al sur del patio de la Ikastola Oleta junto al punto de control de amianto A6, proporciona una medida sustituta para evaluar la generación y distribución potencial de fibras aerotransportadas ya que el monitoreo de las fibras de amianto no es útil en tiempo real para tomar decisiones de gestión sobre la efectividad de los controles debido a los retrasos analíticos.

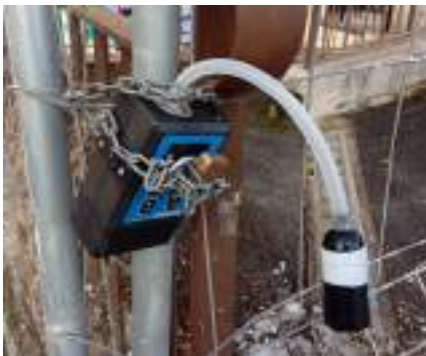
Muestreo en el punto A1 (09.09.19)

Punto	Cód. lab.	Volumen (L)	Densidad (f/mm <sup>2</sup> )	Concentración (f/cc)	Presencia de amianto
A1	6875206	518	<9,62	<0,0071	No detectada
A2	6875207	520	<9,62	<0,0071	No detectada
A3	6875208	521	<9,62	<0,0071	No detectada
A4	6875209	520	<9,62	<0,0071	No detectada

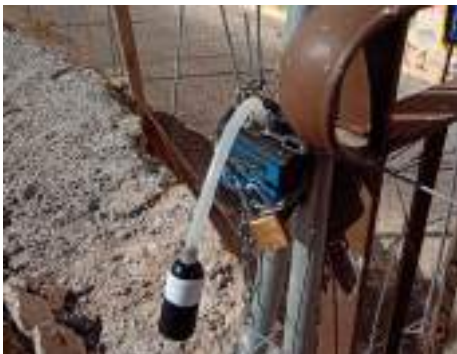
Muestreo en el punto A1 (10.09.19)

Punto	Cód. lab.	Volumen (L)	Densidad (f/mm <sup>2</sup> )	Concentración (f/cc)	Presencia de amianto
A1	6876649	506	<9,62	<0,0073	No detectada
A2	6876650	514	<9,62	<0,0072	No detectada
A3	6876651	506	<9,62	<0,0073	No detectada
A4	6876652	507	<9,62	<0,0073	No detectada

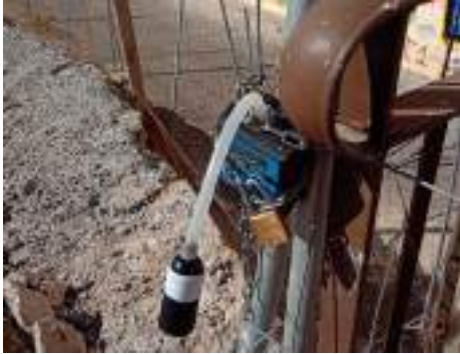
Muestreo en el punto A1 (11.09.19)

Punto	Cód. lab.	Volumen (L)	Densidad (f/mm <sup>2</sup> )	Concentración (f/cc)	Presencia de amianto
A1	6877068	516	<9,62	<0,0072	No detectada
A2	6877069	527	<9,62	<0,0070	No detectada
A3	6877070	522	<9,62	<0,0071	No detectada
A4	6877071	521	<9,62	<0,0071	No detectada
BL	6877072	Blank	<7,69	NA	No detectada

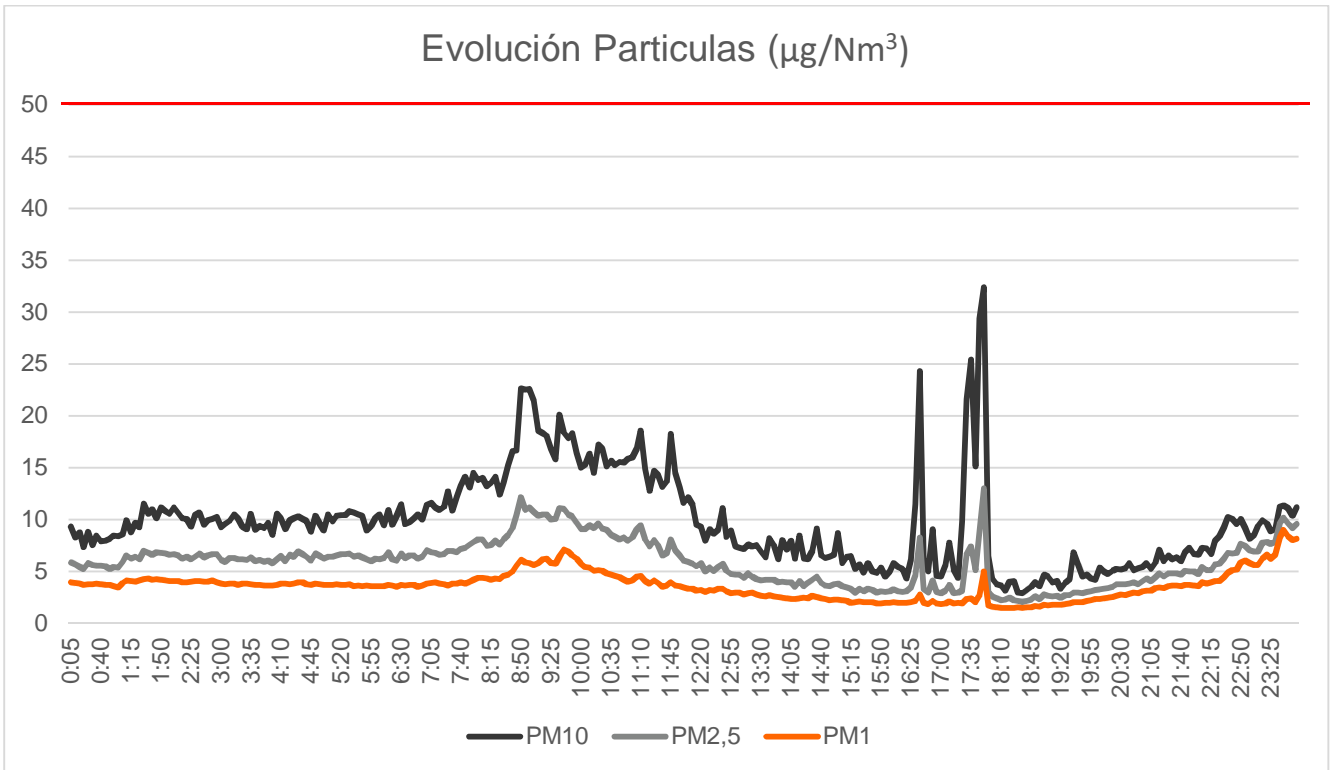
A continuación, se presentan los resultados de las partículas obtenidos durante el control ambiental de amianto.

Periodo	Partículas PM10 ( $\mu\text{g}/\text{m}^3$ )			Partículas PM2.5 ( $\mu\text{g}/\text{m}^3$ )			Partículas PM1.0 ( $\mu\text{g}/\text{m}^3$ )		
	media	máxima	mínima	media	máxima	mínima	media	máxima	mínima
09/09/2019	6,53	18,34	2,27	5,22	11,65	1,72	4,29	10,48	1,24
